# Better Homes and Gardens®

Before-and-after home fix-ups p.129

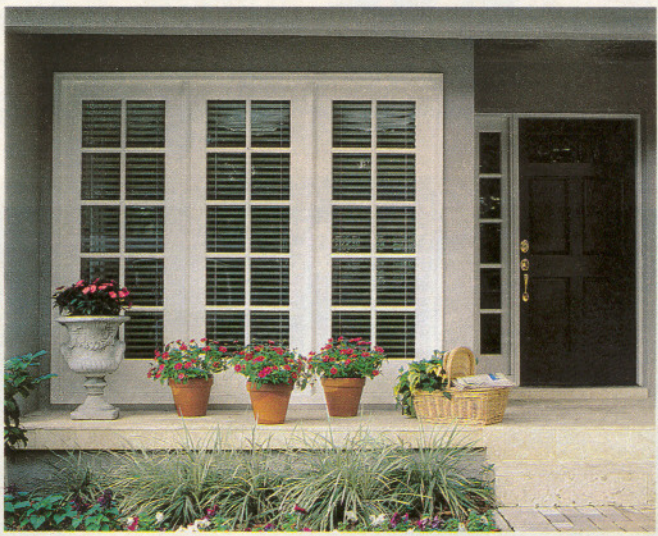
**before** A flat roof and flat facade were the home's key features. Built of concrete block, it had never been painted or treated with stucco.

The exterior of Tammy and Paul Gidus' 1957 ranch could be summed up in one word: flat. That's why Paul, a contractor, focused his remodeling efforts on adding dimension to the home's roofline and facade. "I wanted a different roof for cosmetic reasons," Paul says, "but I also wanted to create an attic storage area and a place for the ductwork of a new air-conditioning system." To give the facade depth, he pushed the dining room windows out from the front door, but not as far as the kitchen windows. The stepped pattern creates a small front porch and shelters the doorway.

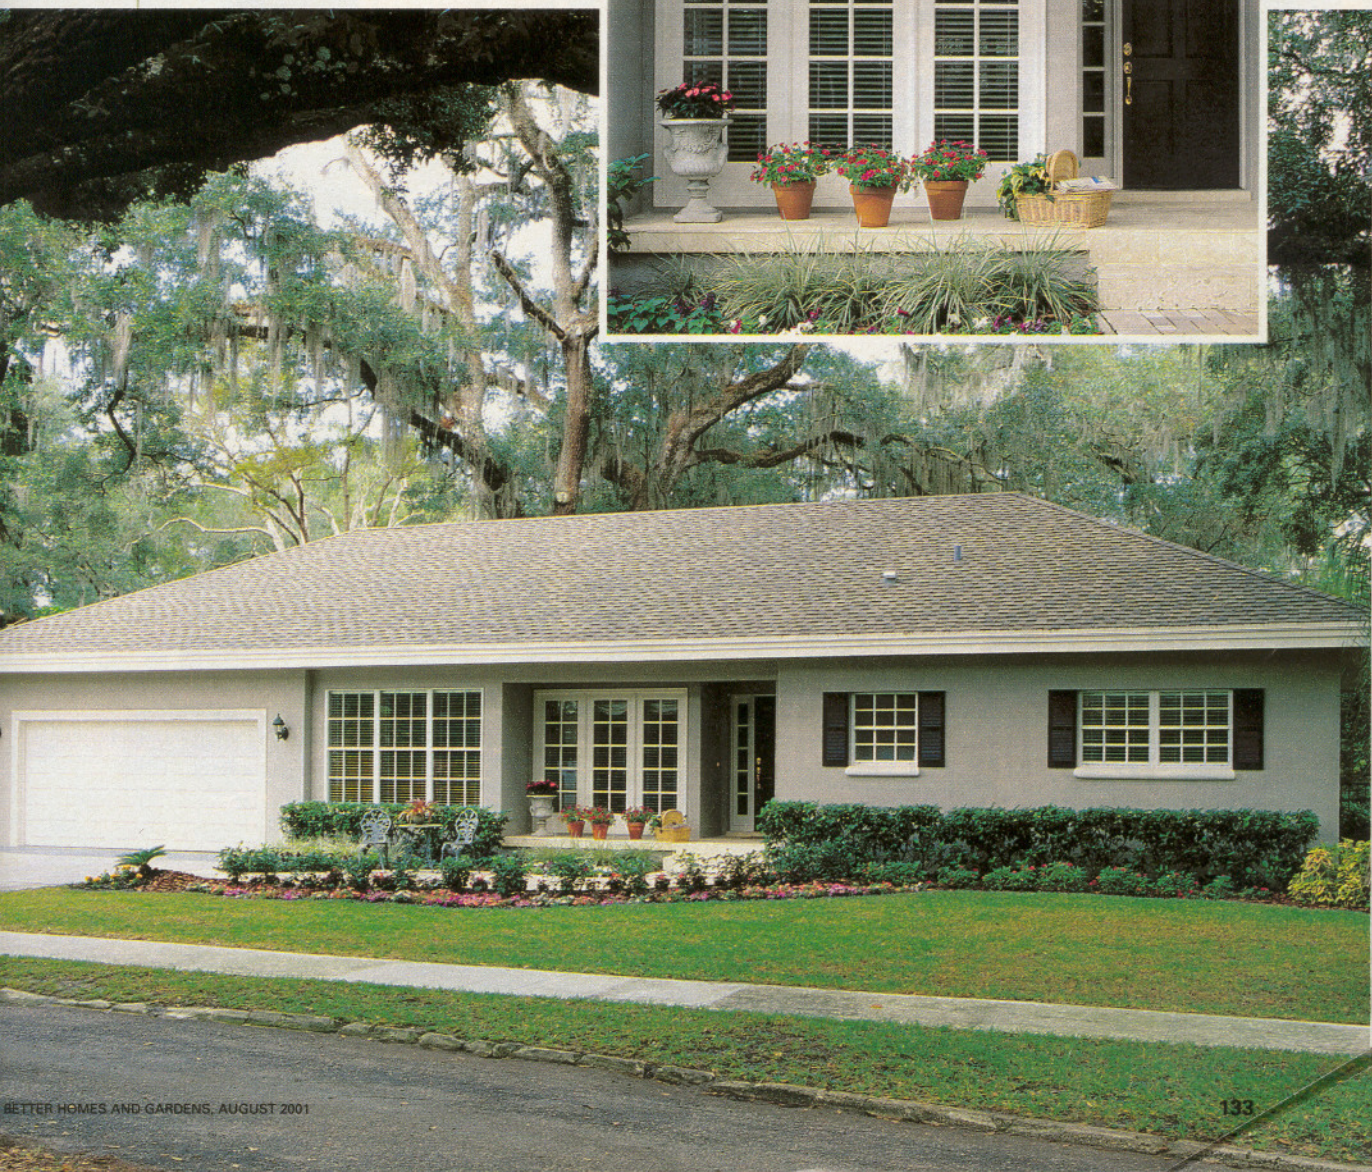
**after** A hip roof with fungus-resistant asphalt shingles (important in Florida, where fungus can grow on roofs) gives the home a classic look. Gray stucco walls, white trim, a burgundy door, black plastic shutters, and a brick walkway complete the scheme.
